Building Envelope Specialists
SPECIALIZED BUILDING CONSULTANTS

RE: Bar Harbor Town Hall Window Evaluation

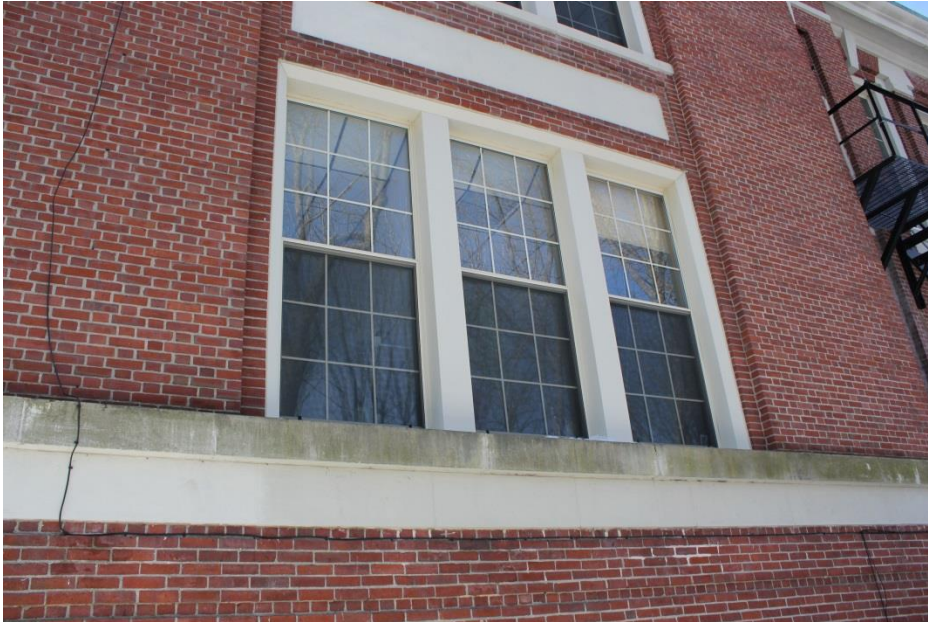
Typical Large double hung window.

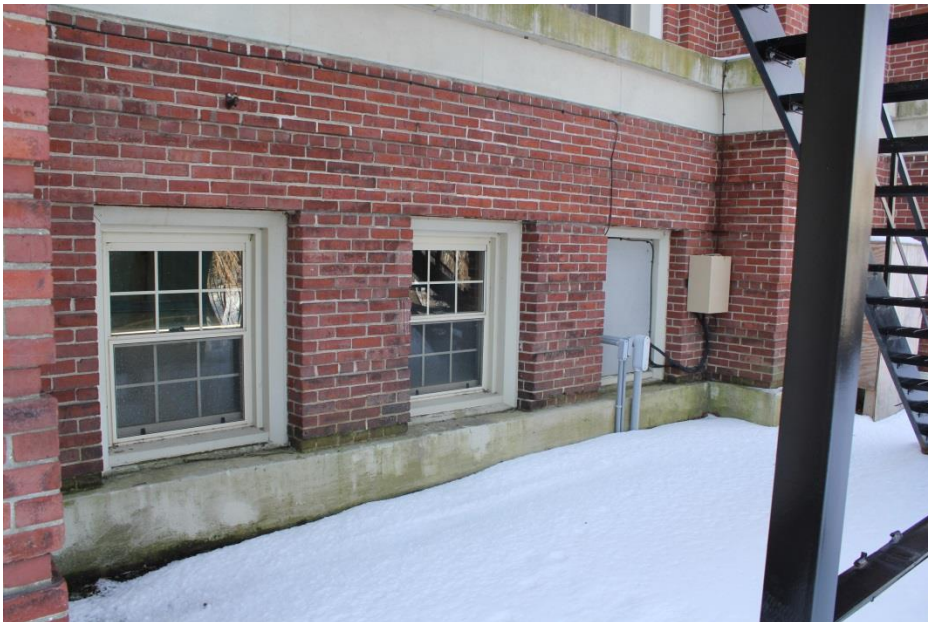
Typical Lower level windows.

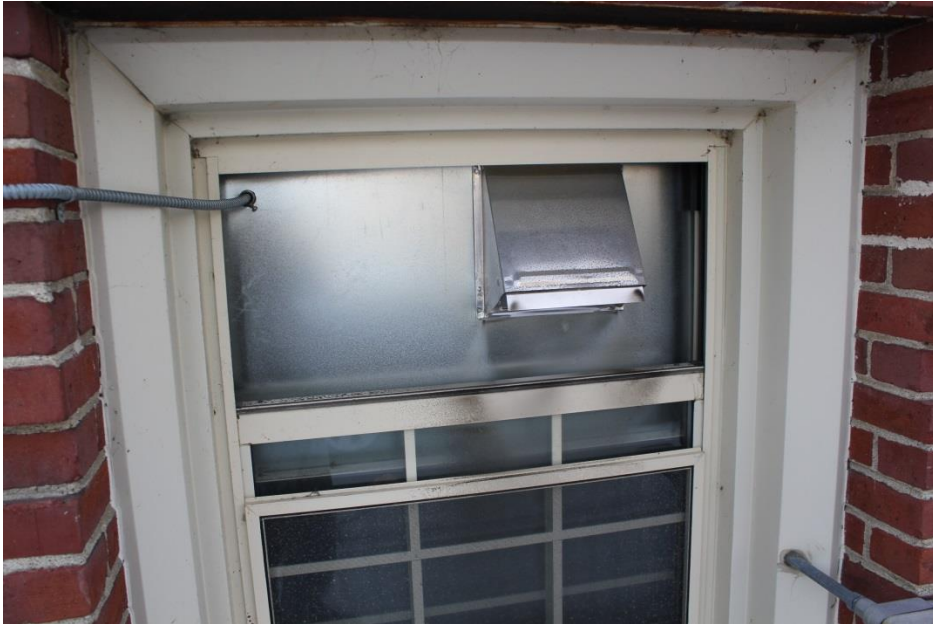
- A window, on the lower floor, is being used for mechanical ventilation. This is not an appropriate installation as it allows for infiltration of rain and snow. This can be remedied by replacing the upper sash with a fixed panel and a proper HVAC exhaust connection.

Recommend a solid panel be installed in the upper sash for proper HVAC venting.

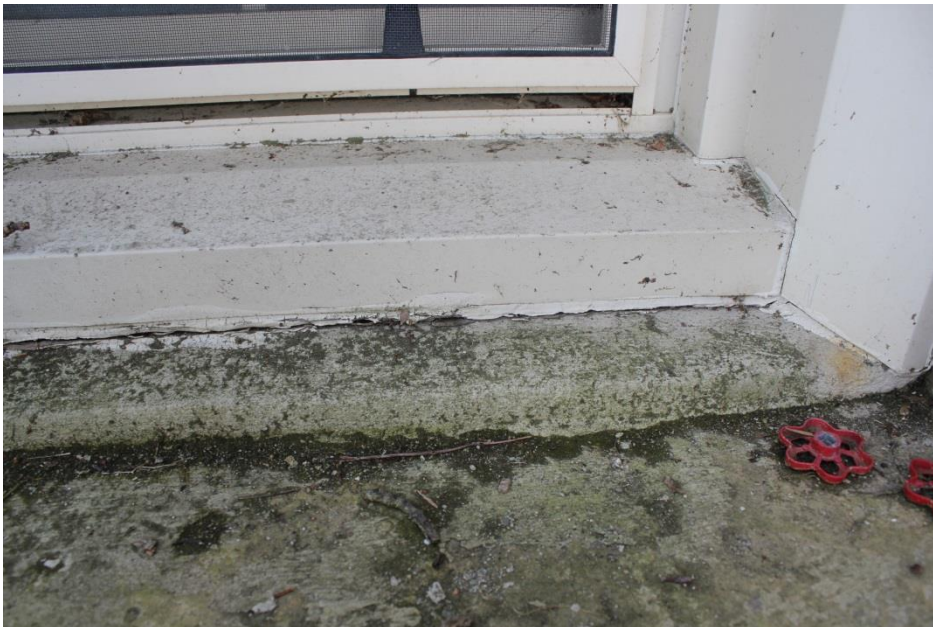
- At the exterior there are signs of corrosion. In some areas the finish is peeling from the aluminum.
- The exterior sealant is failing in many locations.

Typical deteriorated sealant

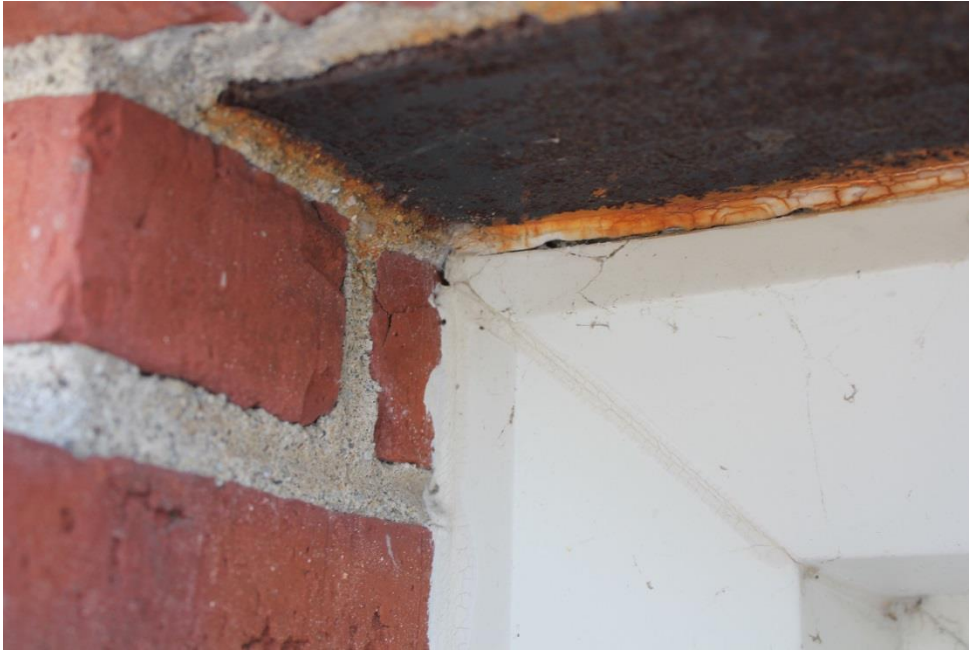
- There is some staining on the exterior break metal from rusting relieving angles.
- These windows are at the 20 year mark in their life cycle, expect seal failures to increase, glass to fog and retainer clips to continue to deteriorate and possibly break.

Rust stained and failing sealant

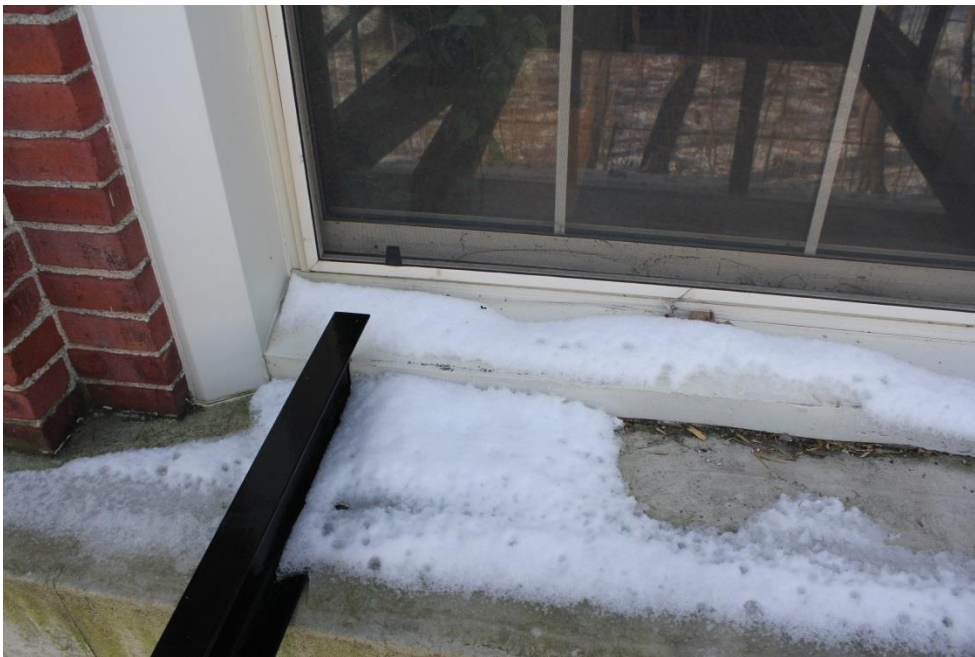
Standing Snow and damp, notice algae on sill and deteriorated sealant.

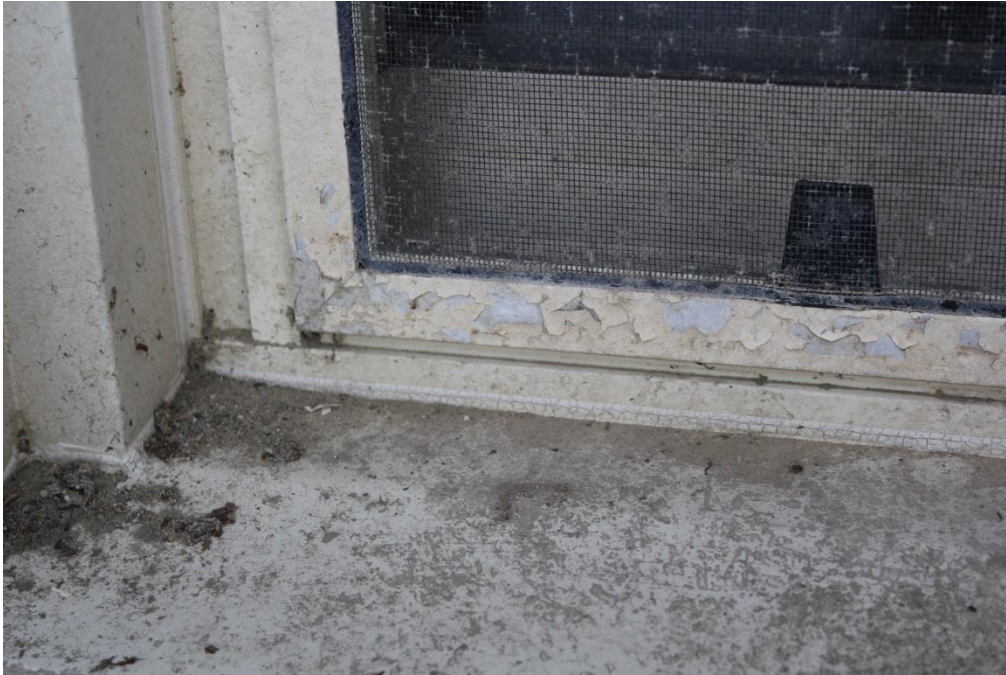
Finish failure, peeling from aluminum.

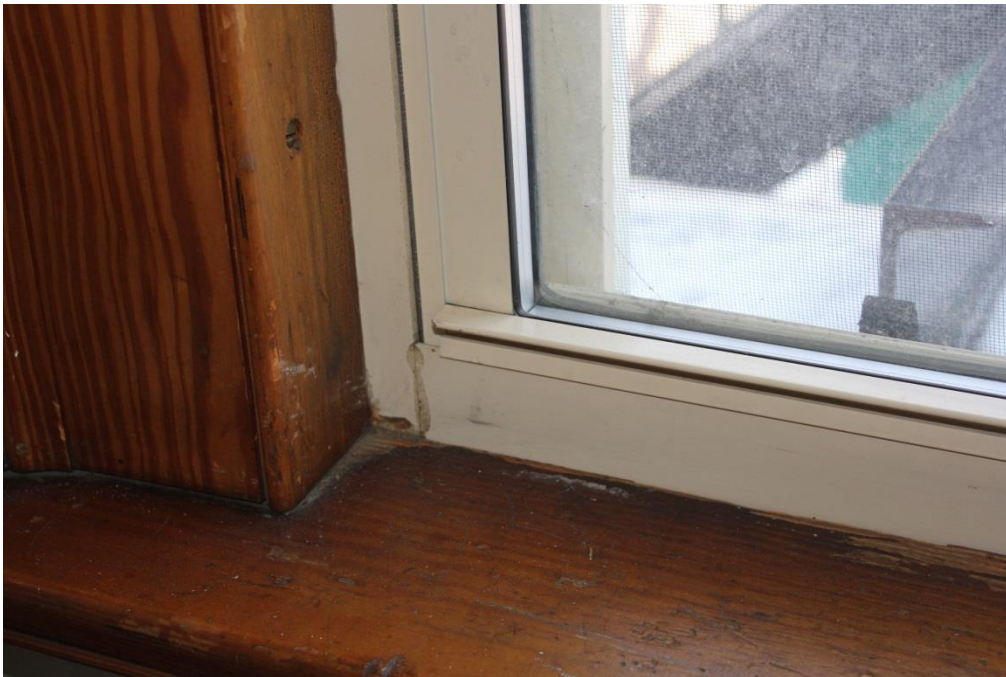
Typical interior sill, this window is not closed properly or locked. I could not close or lock it by myself.

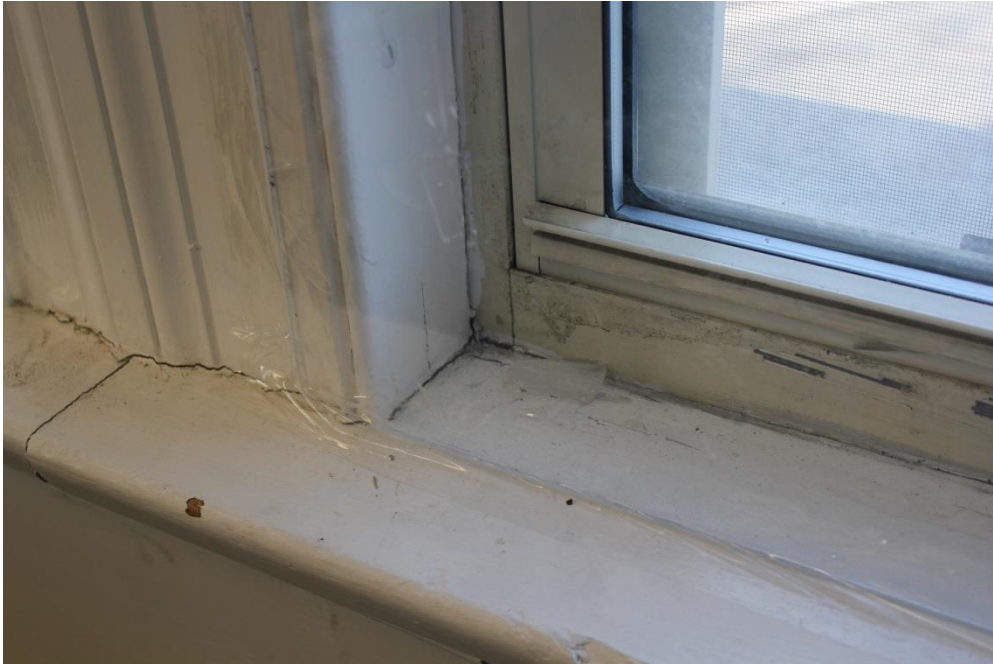
- The code enforcement officer has stated that her hair blows when the wind blows on the west side of the building.
- A third floor window measuring 5'x10' with sashes of 5'x5' came loose and tipped in on the person trying to open it. The person was not hurt and the window was put back in place. A sash this large can weigh upwards of 130 lbs. At a later date the sash did blow inward and broke. It was repaired and screwed into place. This unit is no longer operable. It is unclear why this sash came loose. It could have been installed incorrectly or the plastic retaining clips may have broken. Regardless, any failure of a sash to remain in place can cause injury or death to building occupants.

Window at Code enforcement office. Notice acrylic sheet and tape used to stop draft.

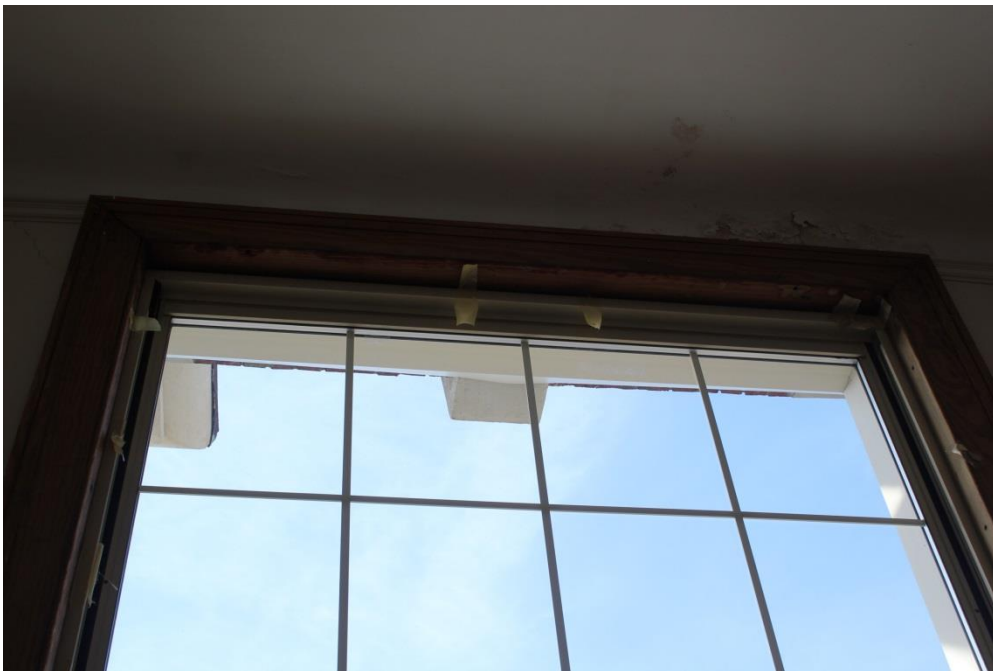
Top of failed window that remains screwed shut.

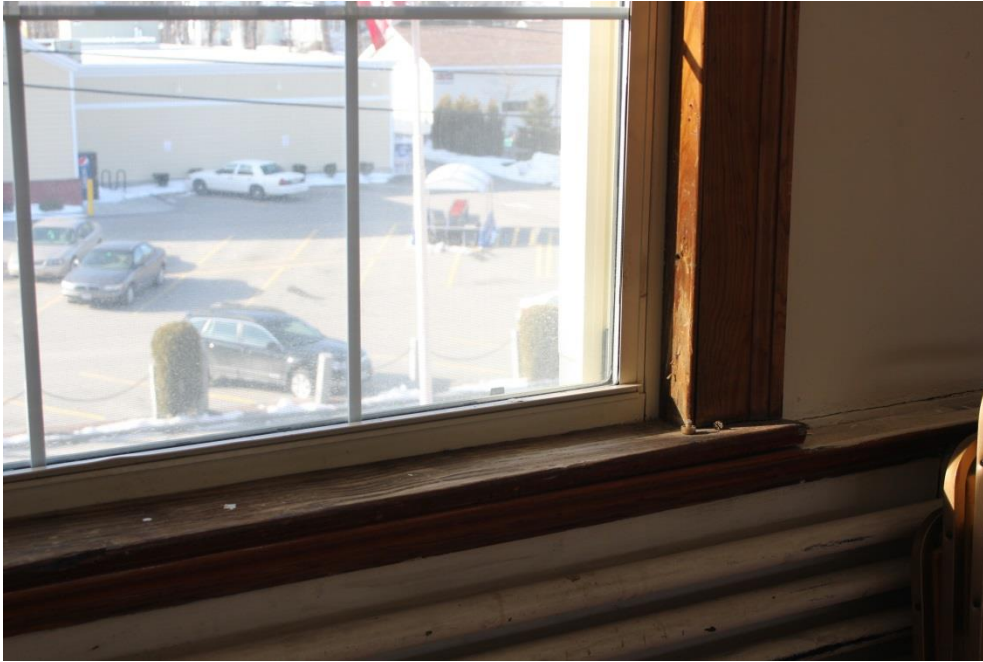
Bottom of failed window screwed shut
